# Tram interface crashworthiness

Trams are a cultural icon as well as a tourist attraction in Melbourne Australia. Their operation is passionately discussed on a regular basis by the Melbourne media. However issues relating to their impact on road safety is largely ignored except for a few articles [1, 2, 3]. This paper investigates tram accidents and their crashworthiness. Some accident statistics for trams in the Melbourne region and their crash compatibility with cars and pedestrians is discussed. MADYMO tram-into-car and tram-into-pedestrian models are described. The main conclusion drawn is that Melbourne trams are unnecessarily aggressive towards other road users and needs addressing. The results of the paper should provide useful information for tram designers, manufacturers and traffic engineers in other cities where trams are used and insight into accidents involving trams for urban environments similar to Melbourne. Some methods of reducing the aggressive nature of tram front ends are also proposed.

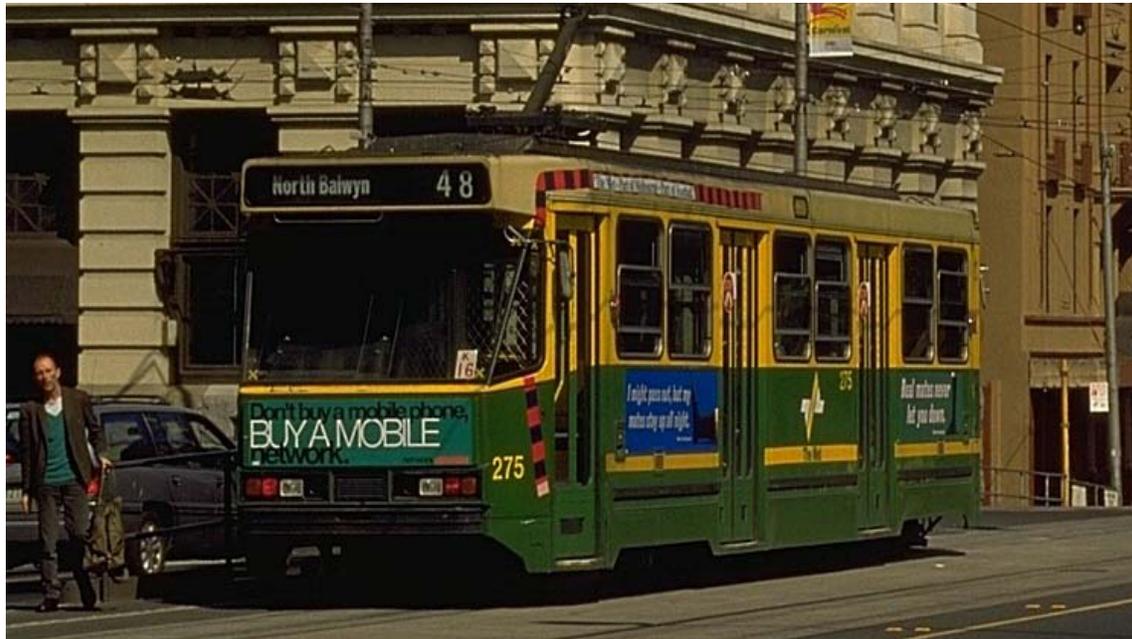
**FIGURE 1** Close-up of steel bumper bar and under run gap below bar on 'A' class tram (22 tonnes). Note pedestrian safety zone between car and tram. (Photo by Clive Mottram from Geocities web site).

Depending on the class of a tram, the height of the steel bumper varies from 520-820 mm with a large gap below it. Figures 1, 2, 3, 4 and 7 show the front ends of 'A', 'W', 'Z3' and B class trams respectively. The gap below the tram's steel bumper is clearly visible. When a tram impacts the side of a car it over-runs the base sill or rocker panel of a car which is at an average height of just under 300 mm. Figure 8 shows how the front of a B class tram compares to the sides of different cars. It is clear that the tram misses the most structurally sound part of the car. Instead of pushing the car, the aggressive front end intrudes into the car's occupant compartment through the middle of the relatively soft door panel just below the window as shown in Figures 5, 6 and 7.

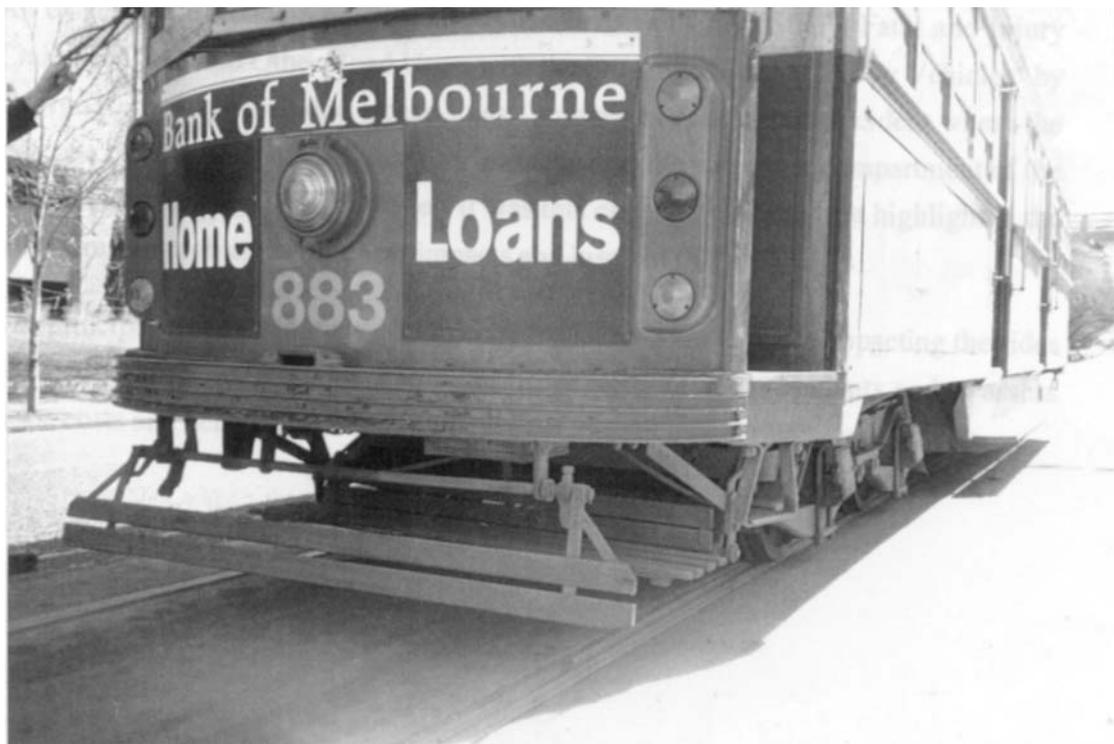
**FIGURE 2** 'W' class tram (17.7 tonnes) showing steel bumper height and under run frame.
